Technical Report REMR-OM-18
June 1997

REMR Management Systems—Navigation Structures, Condition Rating Procedures for Roller Dam Gates

by *Lowell F. Greimann, James H. Stecker, and Timothy A. Kraal*
Department of Civil and Construction Engineering
Iowa State University

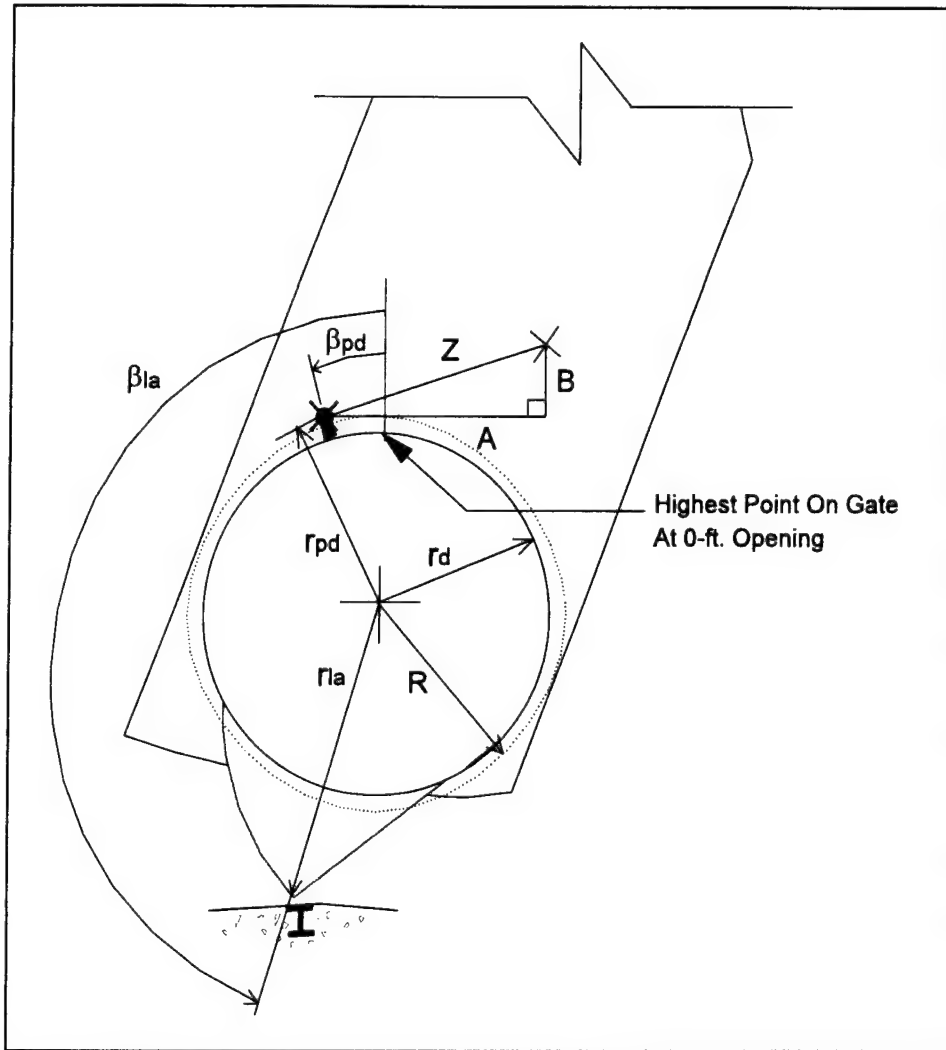
Figure A.1. Torsional misalignment geometric parameters.

Assuming that the nondriven end of the gate lags the driven end, the rotation measured on the driven, θ_{drv} , and nondriven, θ_{ndrv} , ends of the gate when the steel is at 1/3 of yield shear strain are:
